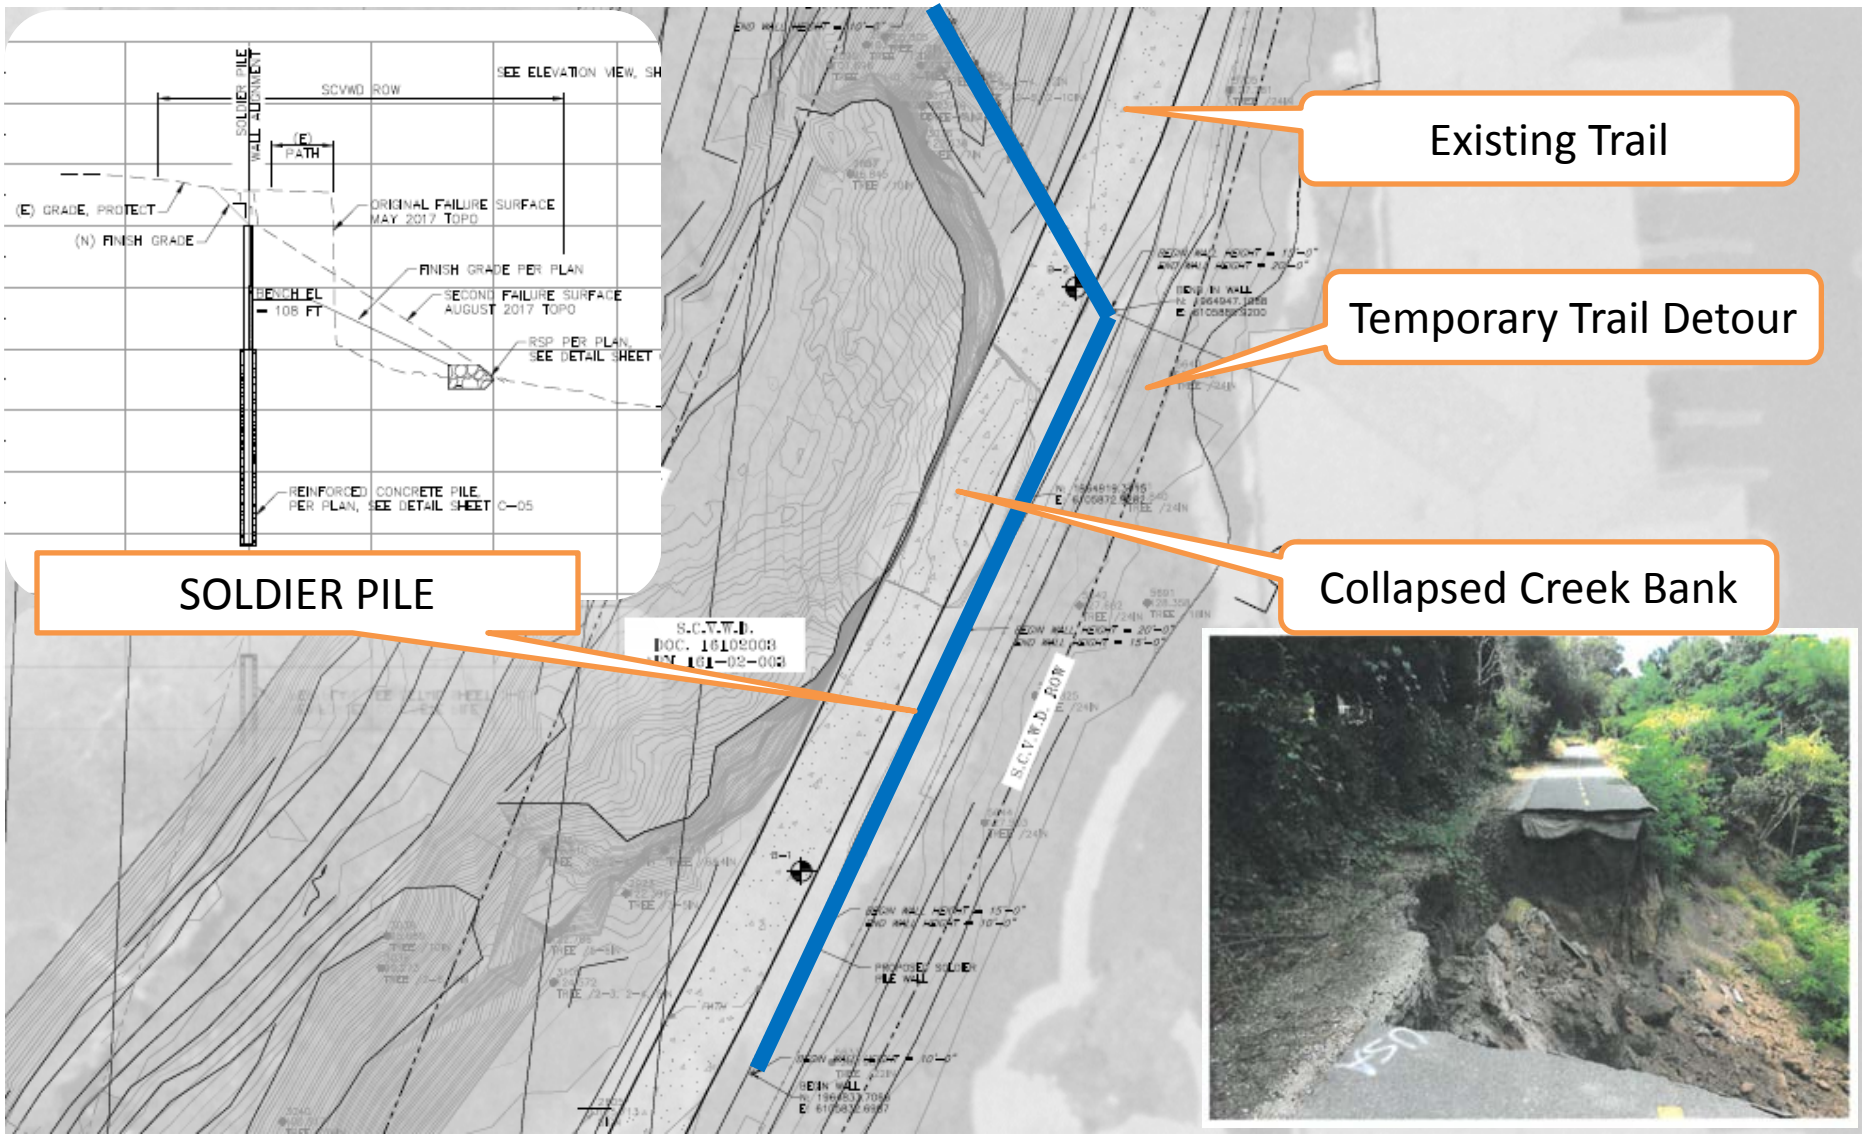
SOLDIER PILE WALL ALIGNMENT
SCVWD ROW
SEE ELEVATION VIEW, SH
(E) PATH
(E) GRADE, PROTECT
(N) FINISH GRADE
ORIGINAL FAILURE SURFACE MAY 2017 TOPO
FINISH GRADE PER PLAN
BENCH EL = 108 FT
SECOND FAILURE SURFACE AUGUST 2017 TOPO
RSP PER PLAN, SEE DETAIL SHEET
REINFORCED CONCRETE PILE PER PLAN, SEE DETAIL SHEET C-05
S.C.V.W.D.
DOC. 16102008
S.C.V.W.D. ROW
PROPOSED SOLDIER PILE WALL
BEGIN WALL
Existing Trail
Temporary Trail Detour
SOLDIER PILE
Collapsed Creek Bank
